**LONG LIFE ELASTOMERIC AIRCRAFT  
HYDRAULIC SEALS  
PART III**

**PARKER HANNIFIN CORPORATION  
SYSTEMS DIVISION AND SEAL GROUP**

TECHNICAL REPORT AFML-TR-73-90, PART III  
FINAL REPORT COVERING PERIOD 15 FEBRUARY 1974 to 15 AUGUST 1975

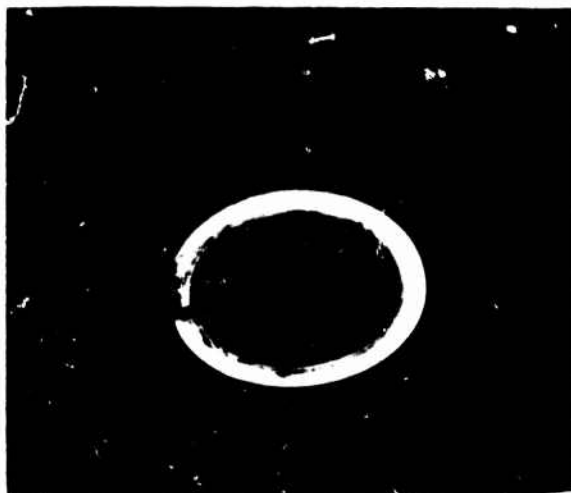
FIGURE 1.

MS28774 scarf-cut Teflon  
backup ring from yoke No. 2  
after 102 hours accumulated  
time at 275°F.

Test stopped due to failure  
of Parbak in same test  
apparatus. (Yoke No. 1)
